# The diversion works for the Cua Dat CFRD in Vietnam

Michel Ho Ta Khanh, Dinh Sy Quat, Prof Pham Hong Giang  
VNCOLD  
No 95/10 Chua Boc Street  
Dong Da District  
Hanoi  
Vietnam

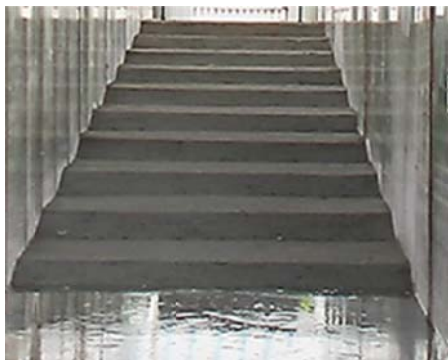
Figures 6

The Figure 6 shows the downstream steps of the partial dam and the Figure 7 shows the commencement of the degradation of the fill under the gabions for the high discharges.

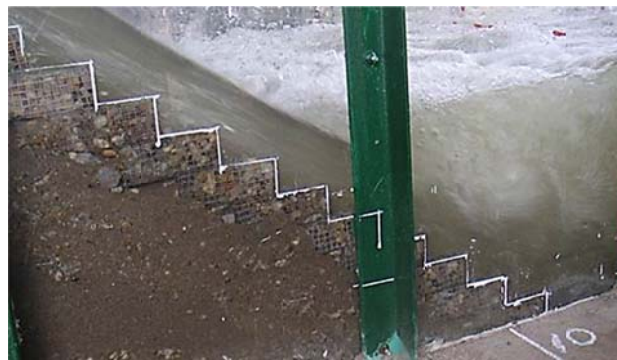
Figure 7

Results of the tests: available alternative for the tested specific discharges, but this type of protection requires the use of steel bars in place of wire mesh, a filter layer between the rockfill and the gabions and a reliable protection at the toe of the dam.

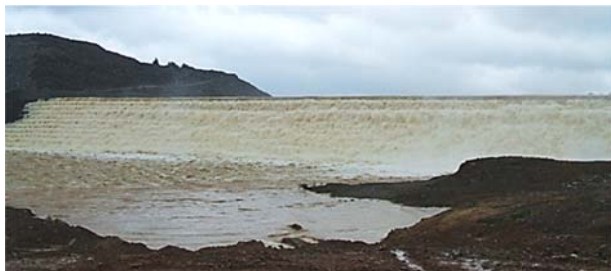
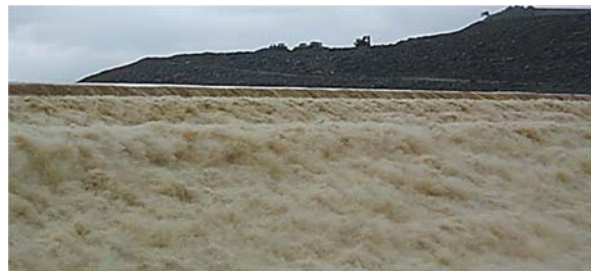
In October 2007, just at the end of the wet season, a very high flood during the typhoon Lekima centered on the site, came unfortunately with the discharge of more than 7000 m<sup>3</sup>/s. It's higher 37% than the designed one. The flood lasted 48 hours. The erosion begun when the discharge was over 2200 m<sup>3</sup>/s, with an overflow depth of 1.5 m. A part of the dam collapsed with a maximum overflow depth of 4 m. The destruction lasted 24 hours, with the opening of a breach from D/S to U/S (L= 70 m, i.e. one third of the dam portion in the channel and with about 350 000 m<sup>3</sup> of displaced rockfill).

The Figures 10 & 11 show the commencement of the overflow.

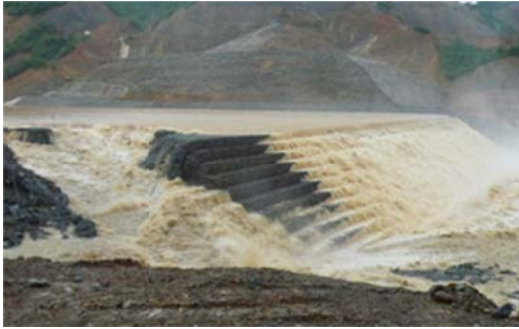
*Figure 12*

As no scour in the bed-rock was observed just after the failure and the existence of an important erosion in the right bank was the consequence and not the cause of the breach, it seems that the initial failure is the destruction of the gabions, with different possible hypotheses (not really proved):

- insufficient resistance of the gabions (which were not well represented in the model by the used wire mesh),
- loss of stability of the gabions (by piping?),
- destruction of the gabion mesh by the floating debris and logs carried by the flood.

The Figure 12 shows the breach in the dam and the right bank and the Figure 13 shows the partial clogging of the diversion tunnel.

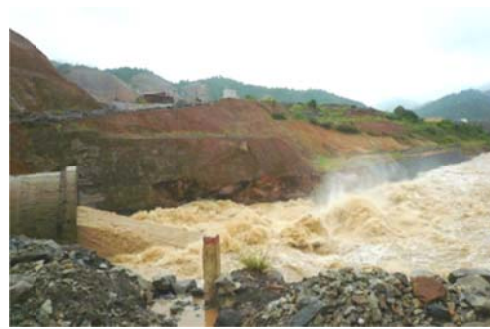
*Figure 13*

The unlined diversion tunnel, with a 9m diameter, was partially clogged during the flood. It is to note that with the traditional method of diversion, where the total discharge is evacuated only by the tunnels, even with a larger diameter, this risk cannot be completely avoided as observed on other examples in the world.

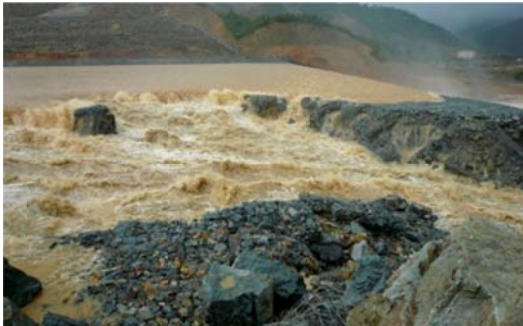
*Figure 14*

The Figure 14 shows the failure of the dam (only on the right bank) and the Figure 15 shows the channel in the river bed after the incident.

The portion of the dam on the left bank was not destroyed probably because the formation of the breach on the right bank has significantly lowered the overflow depth on the remaining part of the dam.

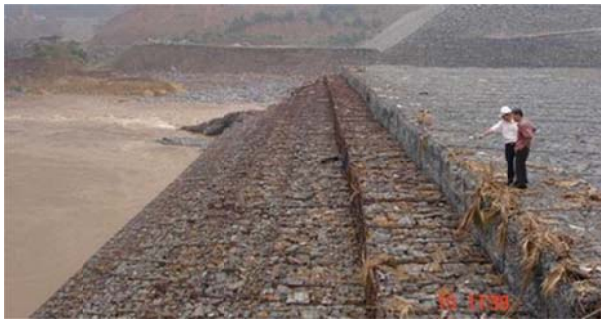
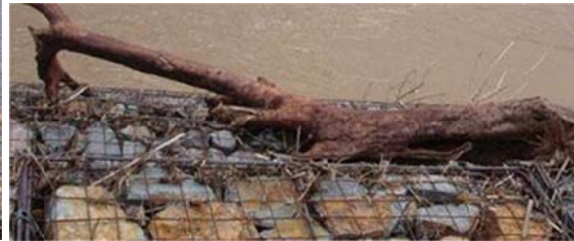
The Figures 16 & 17 show the gabions after the incident with the floating debris hooked in the wire mesh

For the Cua Dat dam, the protection by the gabions was not sufficient for such a high overflow depth, with a flood duration larger than one day. The risk of collapse was augmented by the flood transporting a lot of floating debris and logs. This type of protection should require the use of strong steel bars in place

of a simple wire mesh, a filter layer between the rockfill and the gabions and a reliable protection at the toe of the dam: this protection won't be finally cheaper than a protection by a RCC layer.
