Secondary Processes Associated with Landslides in Vietnam

Keywords: Landslides · Secondary processes · Dam reservoir · Cause · Mechanism · Vietnam

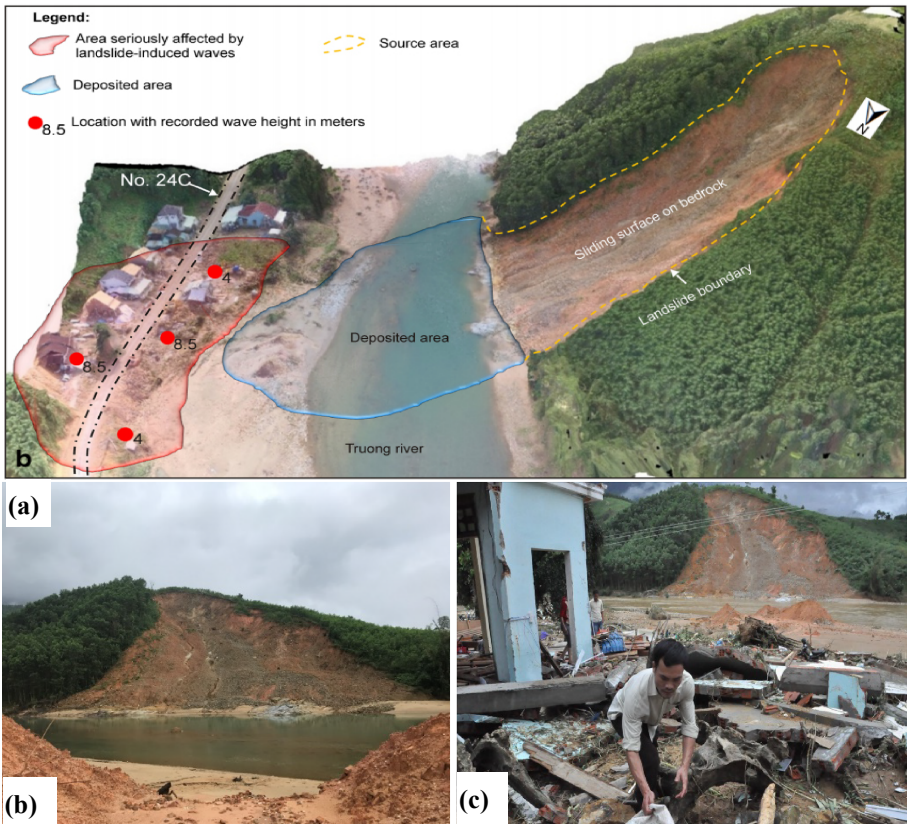
Fig. 4. (a) 3D view of the Tra Giang landslide [59]; (b) Landslide after sliding (photo by Dinh Thi Quynh); and (c) Collapsed houses due to tsunami waves [63].

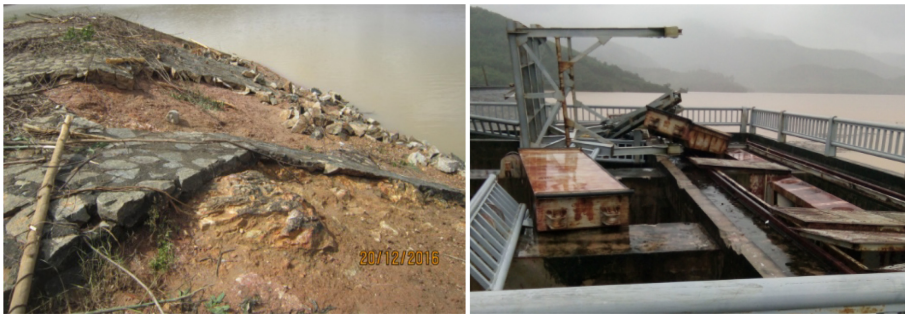
Fig. 6. Damages to the Van Hoi dam and its facilities due to landslide-generated waves (Photo courtesy by Do Canh Hao).

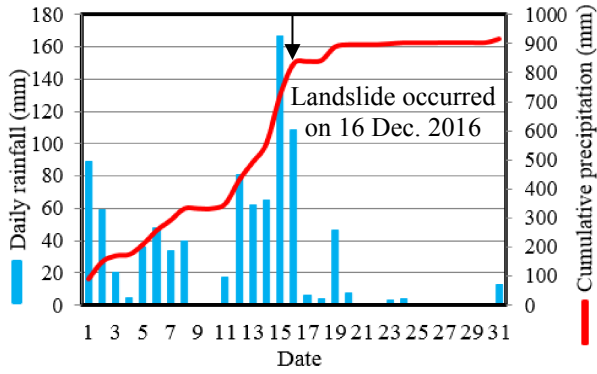
Fig. 7. Daily rainfall in December 2016 and landslide occurrence.

Precipitation data before and after the landslide occurrence monitored at Hoai An rain gauge station in Tang Bat Ho district, approximately 6 km from the reservoir site, are shown in Fig. 7. It shows that the landslide was triggered by heavy rainfall. The accumulative rainfall prior to the sliding was over 800 mm in December 2016.

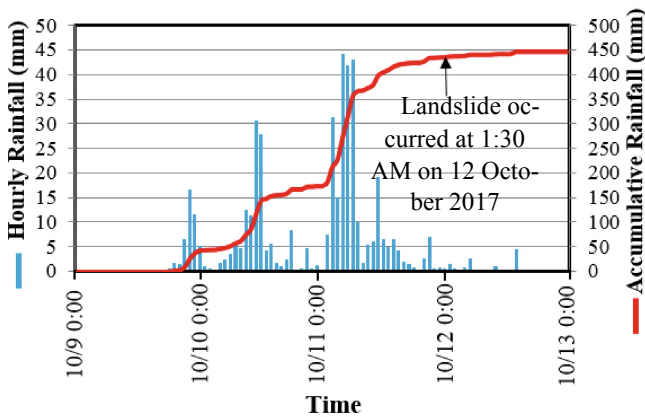
Fig. 10. Landslide occurrence time and hourly rainfall data at Mai Chau meteorology station.

the North-West of Vietnam, which is strongly affected by active faults in the east-west direction [65]. Some lineaments as active faults can be delineated on satellite images around the Khanh village slope in Fig. 9b. Based on the site survey, a geological slope profile of the landslide was created in Fig. 9c. It presents that the landslide area consisted of weathered materials of limestones in Devonia-Slurian Age and sedimentary rocks. The slope slid along the sliding surface which was the geological boundary of sedimentary rocks and limestones. The slope with a height of 120 m and width 200 m was triggered by heavy rainfall. The cumulative hourly precipitation that triggered the landslide was 437 mm between 9 to 11 October 2017 (Fig. 11).
