# The diversion works for the Cua Dat CFRD in Vietnam

Michel Ho Ta Khanh, Dinh Sy Quat, Prof Pham Hong Giang  
VNCOLD  
No 95/10 Chua Boc Street  
Dong Da District  
Hanoi  
Vietnam

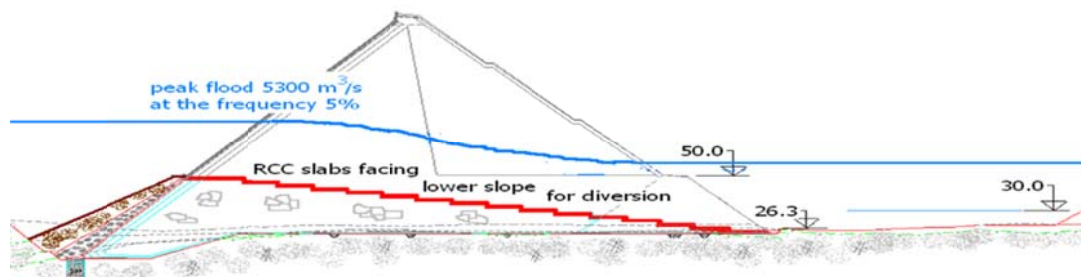
Figure 4: Cross section of the partial dam with a downstream slope face

1) An alternative with a downstream slope face protection by concrete slabs or gabion mats when overtopping (Figure 4).

Results of the tests: this first alternative would be safer with its more progressive dissipation of flood energy. However the third alternative was chosen because it can reduce a little the delay of construction with rather lower cost.

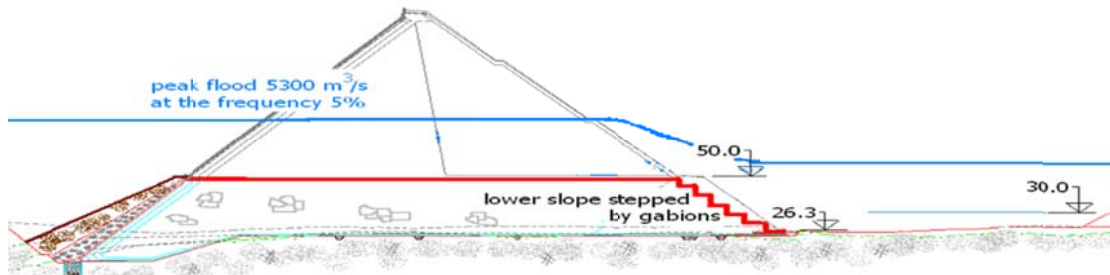
Figure 5: Cross section of the partial dam with stepped gabions on the downstream face

3) An alternative with stepped gabions entirely on the downstream slope face of the dam (adopted alternative) (Figure 5).

Results of the tests: available alternative for the tested specific discharges, but this type of protection requires the use of steel bars in place of wire mesh, a filter layer between the rockfill and the gabions and a reliable protection at the toe of the dam.

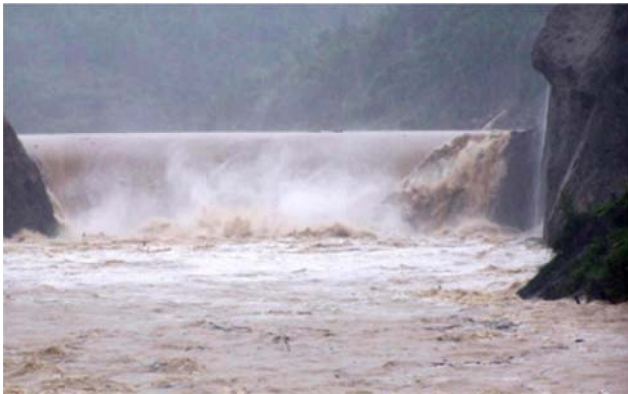
Figure 8

The Figures 8 & 9 show the safe downstream face of the Chinese Hankou RCC cofferdam after an overflow depth of 8m (the RCC contains only 80 kg/m<sup>3</sup> of cement and fly ash with reuse of alluvial aggregates excavated from the river bed).
